Periodic Review

**General Electric/Spokane Site
1997-2002**

**Prepared by:
Guy J. Gregory
Washington State Department of Ecology
Eastern Regional Office**

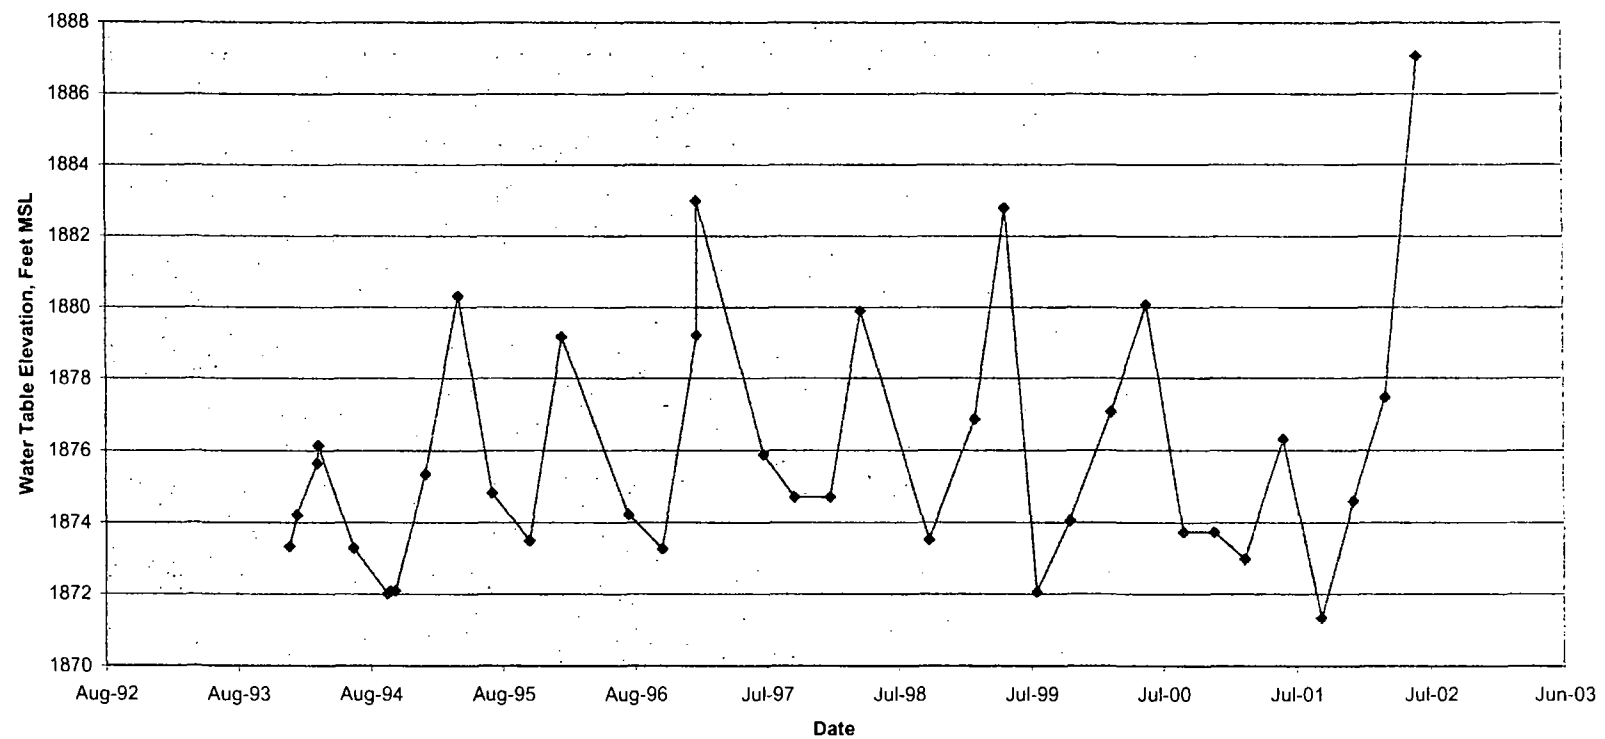
Figure 4
Water elevations MW-1
GE/Spokane Site

Figure 4 uses well data from MW-1 to illustrate water level history at the site since 1994. In general, site ground water elevations have varied over the monitoring period approximately 18 feet. The lowest measured water table elevation occurred in the Fall, 1994 event, while highest water levels occurred in the June, 2002 event. Over the reporting period, a general increase in water table elevation is exhibited. Water table elevation varies with the seasons, maximums generally occurring in the spring, and minimums in the late fall or winter quarters. Water elevations generally rise over a short period of time, and decline over a long period.

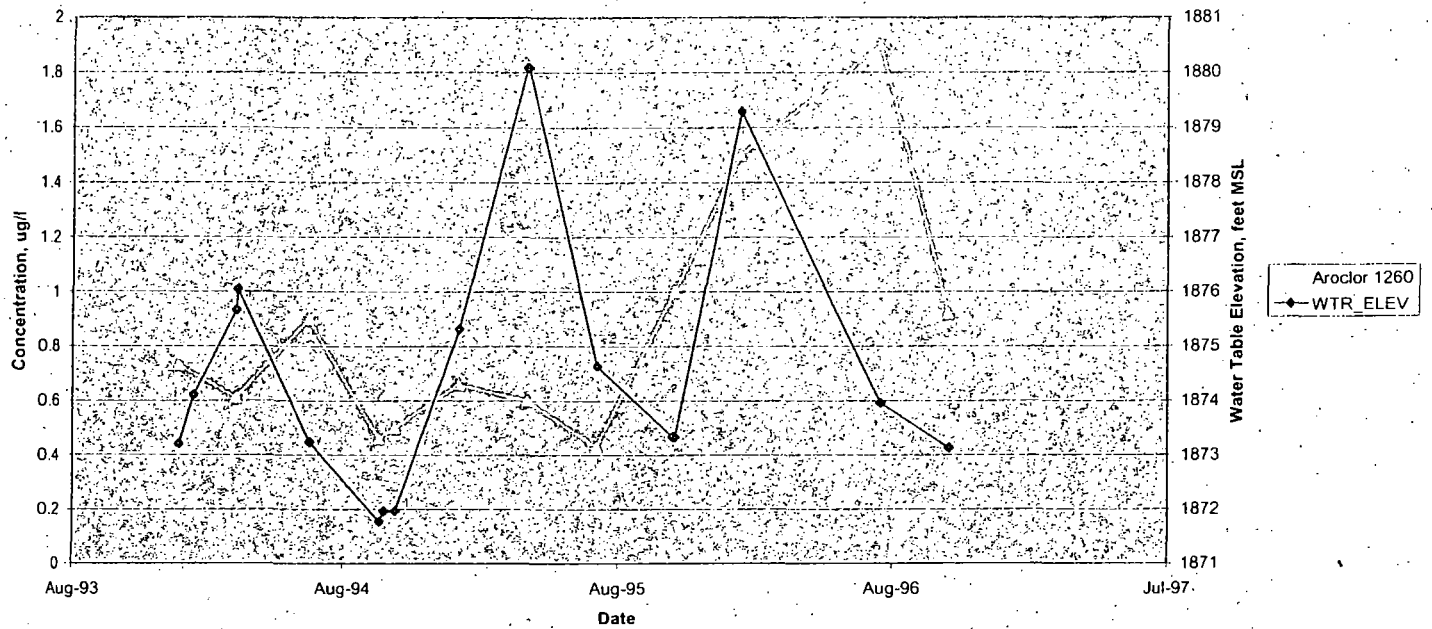
Figure 5a
MW-5
Water Table Elevation and Aroclor 1260 Concentration
GE/Spokane Site

MW-5 represents trends of PCB in ground water prior to soil remedial actions (Figure 5a). Concentrations of Aroclor 1260 approach the solubility limit of the chemical mixture. MW-5 was abandoned in 1996 to allow soil removal.

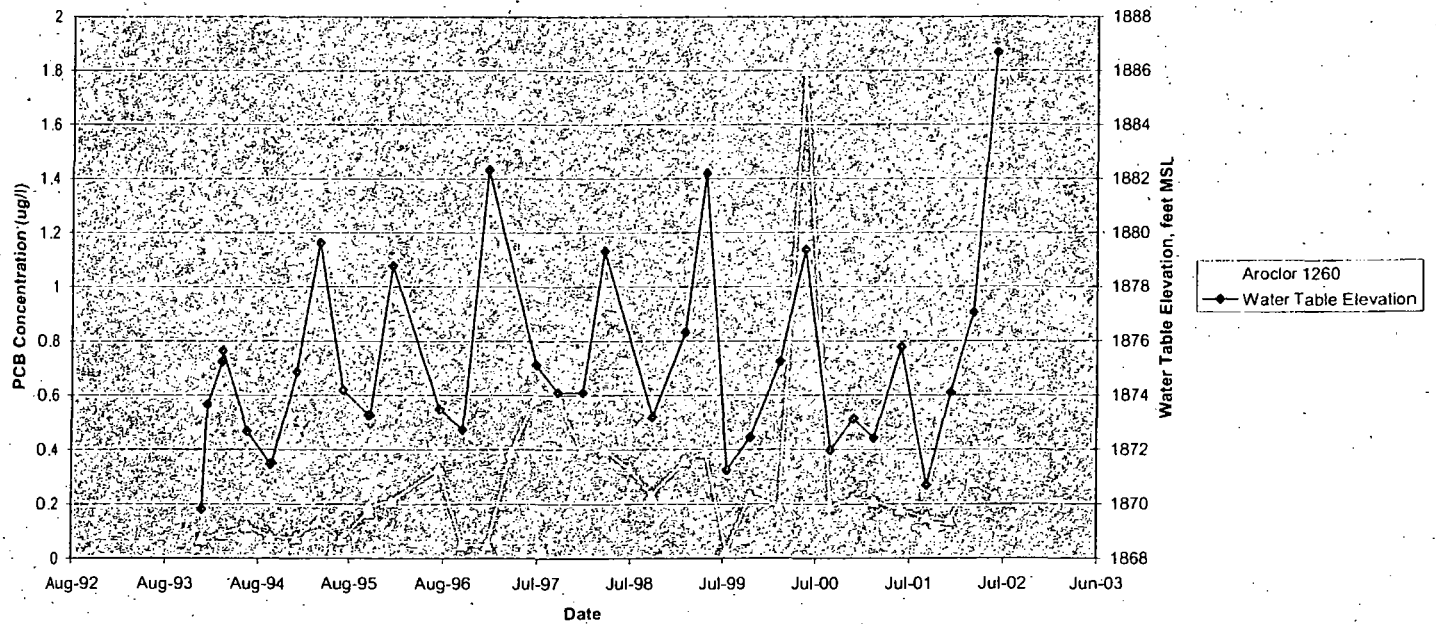
Figure 5b
MW-11
Aroclor Concentration and Water Table Elevation
GE/Spokane Site

Data from MW-11 (Figure 5b) indicates a peak in Aroclor concentrations at the beginning of the review period. This is probably due to site disturbance activities. Data suggest a decreasing trend since 2nd Quarter, 1997, with the exception of an anomalous peak in the 2nd quarter of 2000.

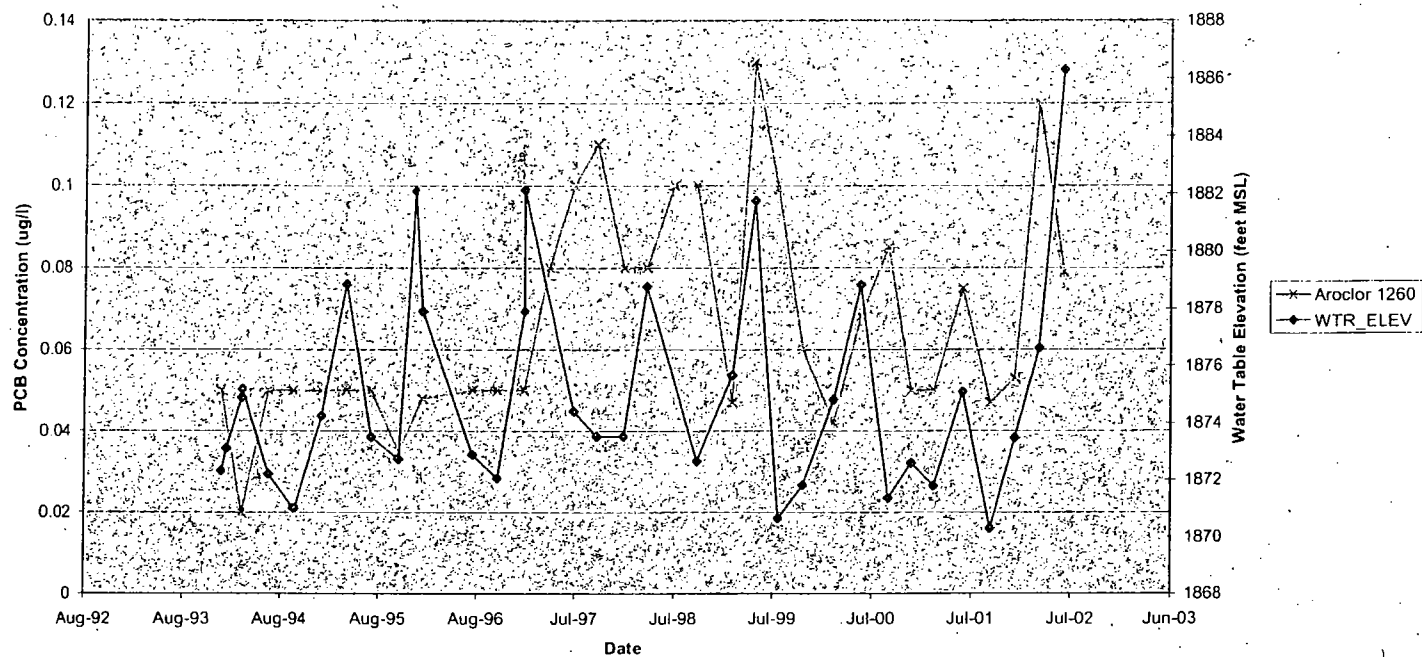
Figure 5c
MW-18 PCB Concentration and Water Level
GE/Spokane Site

A similar pattern to MW-11, (Figure 5c) with a peak in concentration in 2nd Quarter 1997, followed by a generally subtle but present decrease in the observed maximum concentration. Anomalous peaks in 2nd quarter 1999 and 1st quarter 2002, as well as subordinate peaks in concentration in other years, seem related to the sharp spring rise in elevation common in the aquifer.

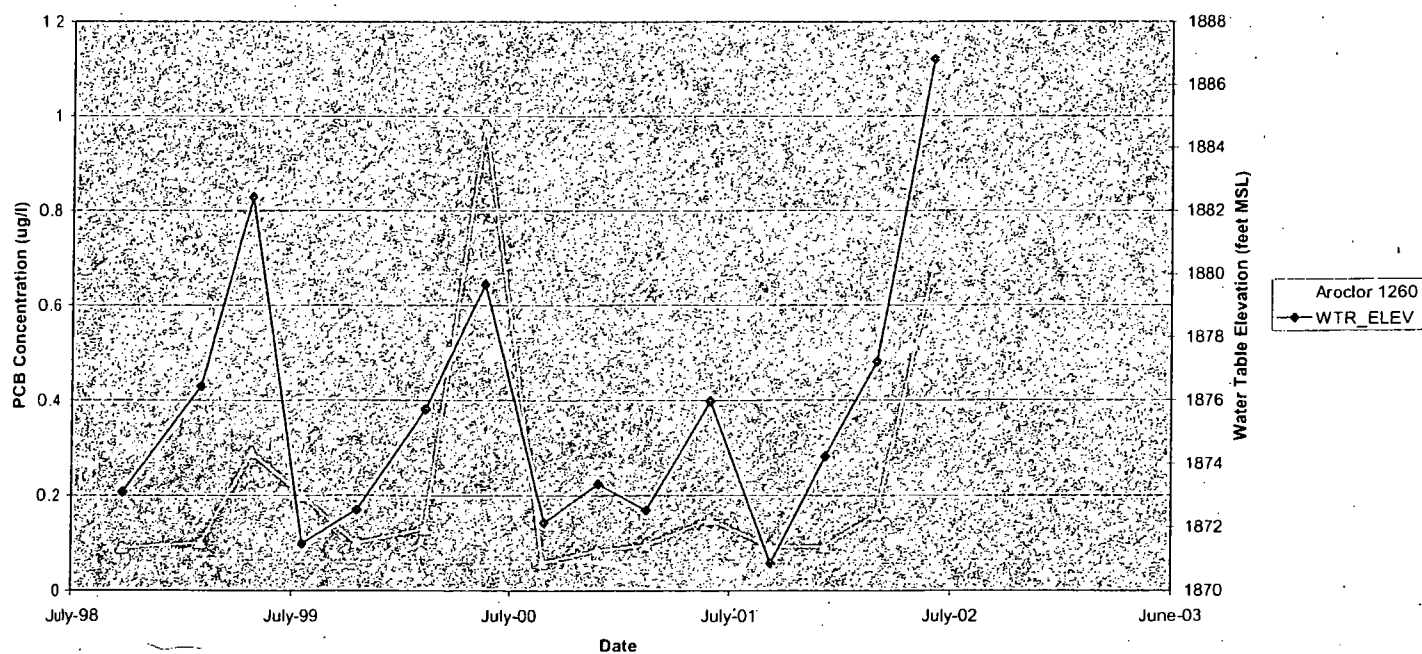
Figure 5d
MW-19 PCB Concentration and Water Levels
GE/Spokane Site

Monitoring in this well indicate values close to detection limits with the exception of detections of PCB in May or June (2nd quarter) sampling events. (Figure 5d)

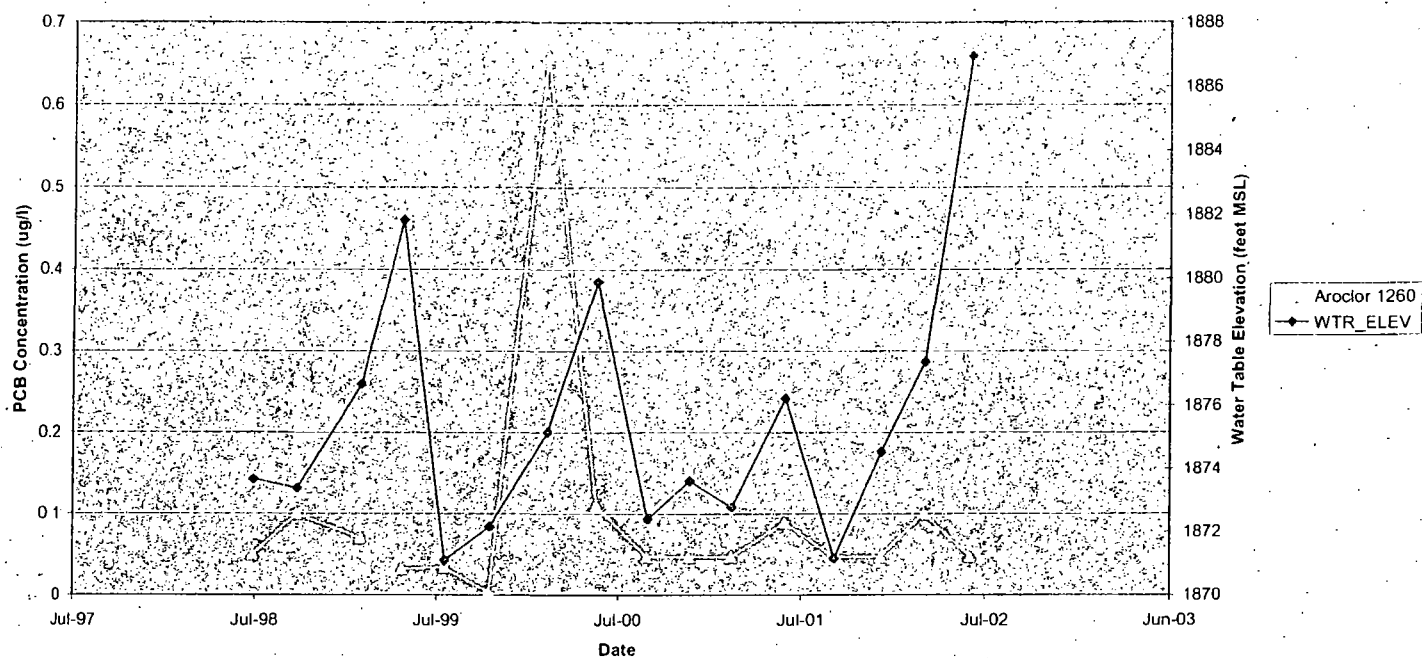
Figure 5e
MW-20 PCB Concentration and Water Levels
GE/Spokane Site

Contaminant trends in this well are generally flat, with the exception of the 1st Quarter (February) 2000 event, however highest concentrations again are generally associated with the sharp spring increase in water table elevation (Figure 5e).

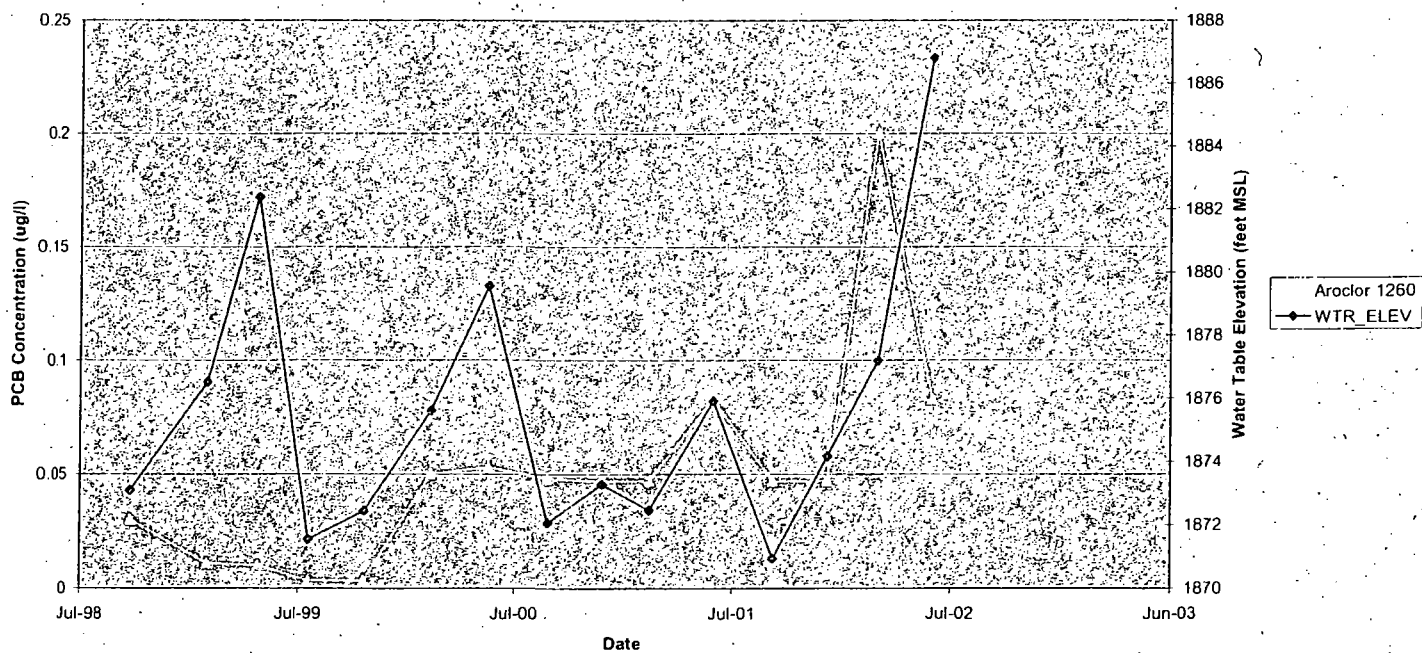
Figure 5f
MW-21 PCB Concentration and Water Table Elevation
GE/Spokane Site

Slight detections occur in MW-21 associated with either the spring or summer ground water quality measurement. The concentration of those detections has increased from 0.053 ug/l to 0.2 ug/l (Figure 5f).

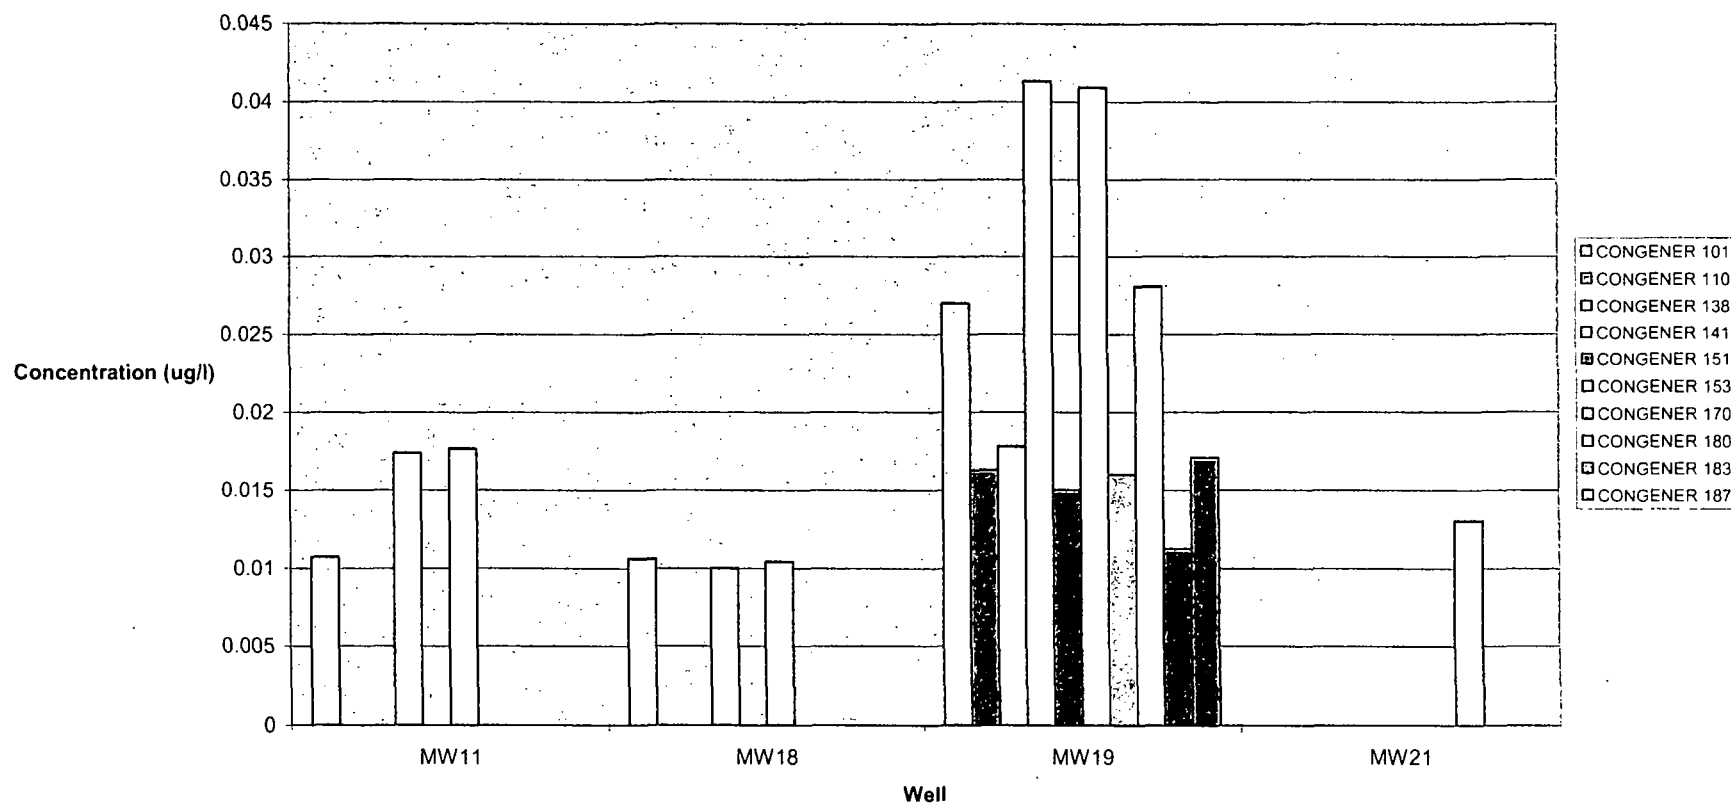
Figure 7
PCB Congener Concentrations-Detected Congeners only
GE/Spokane

In addition to reporting Aroclors, Ecology required congener analysis be performed by the laboratory on the SAIC samples. Those data are indicated on figure 7, which shows detected congeners only. Congeners were detected in wells which detected Aroclors, and wells which had no Aroclors contained no PCB congeners. Higher concentration wells contained higher levels of congeners, but no correlation is apparent between the total detection of quantified congeners and the reported Aroclor concentration. Detection limits for the congeners are significantly lower than for Aroclor mixtures.

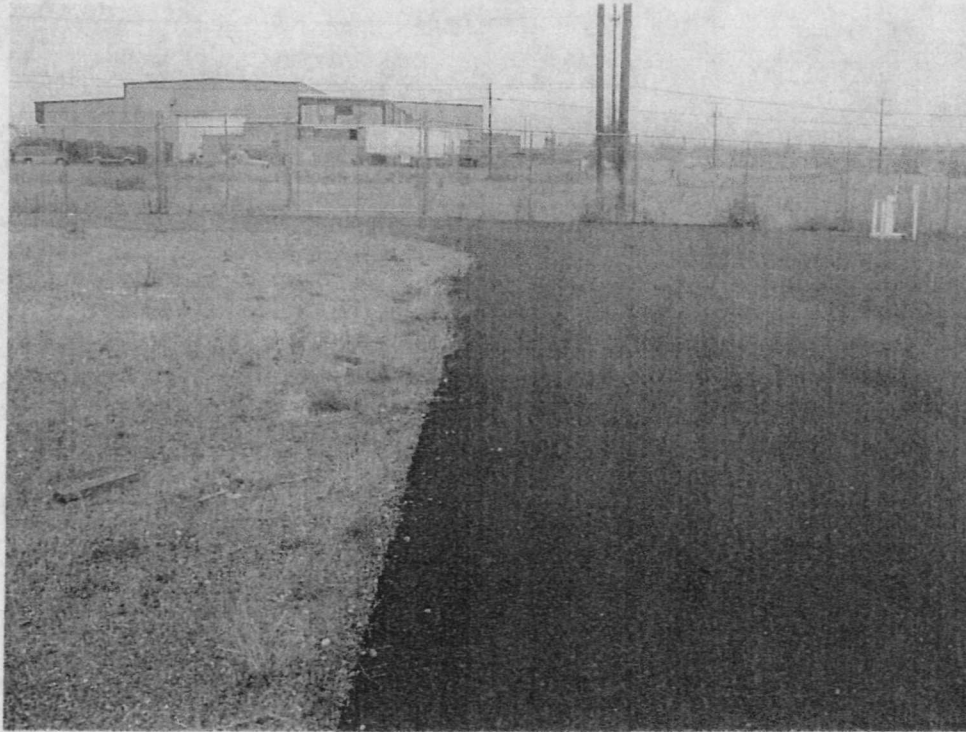
Inspection of the site on November 7, 2002 indicated the site cap is intact. It is serving the purpose of diverting incident precipitation away from contained material, and preventing direct contact or inhalation of contaminated soils. See Appendix A, inspection photos.

North side of asphalt cap

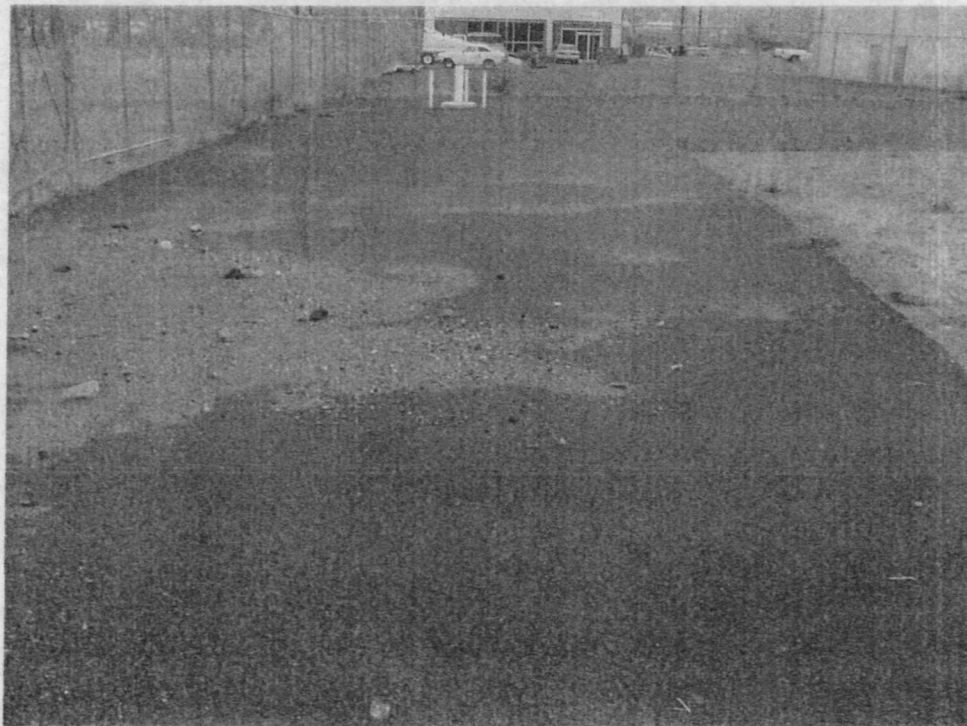
West side of asphalt cap
